Dormant landslides distributed in upper course of Sun Kosi Watershed and landslides induced by Nepal Gorkha Earthquake 2015

*Hiroshi Yagi¹, Kazunari Hayashi², Daisuke Higaki³, Ching-Ying Tsou³, and Go Sato⁴

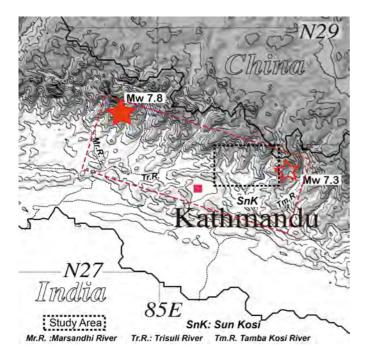
Fig. 1: Study area and topographic outline of Nepal Himalayan region. The two stars locate the epicenters of the M7,8 April the 25th 2015 Gorkha earthquake and the 12 may M7,3 Kodari Earthquake. The large light dashed rectangle delineates the approximate area of the MHT ruptured during the Gorkha earthquake and following aftershocks.

River, Indrawati Nadi, Balephi Khola and the Bhote Kosi River in Nuwakot and Sindhupalanchok districts, northeastward from the Kathmandu Valley, central Nepal (Fig. 1). This area is located in a topographic transitional zone from the Lesser Himalaya to the Great Himalaya behind Kathmandu. Elevation of terrain ranges from 700 to 4500 m a.s.l.

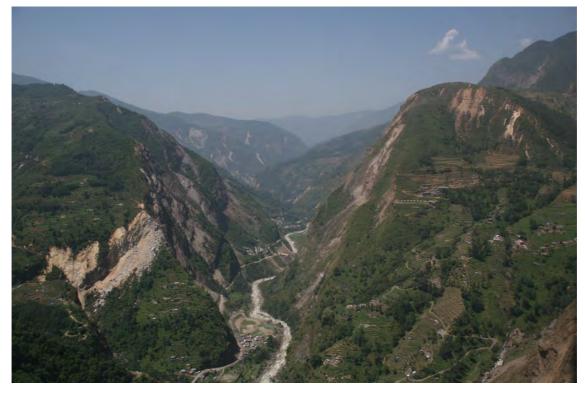
Fig. 6: Shallow landslide triggered by the Nepal Gorkha Earthquake 2015 along the Bhote Kosi Gorge

Numerous landslides were induced by the Nepal Gorkha Earthquake 2015 in mountain slopes just above the fault plane ruptured by the Nepal Gorkha Earthquake 2015. Most of them are shallow landslides which occurred just below break of slope, showing a shoulder shaped profile along the deep gorge (Figs. 2 and 6). Mean slope angle of the earthquake-induced landslide site for each geology type ranges from 37 to 40.6 degrees (Table 2). Strong ground motion was presumably amplified by the topographic effect of the shoulder shaped profile and caused shallow landslides (Meunier et al., 2008; Wakai et al., 2017). They are concentrated in the geological areas of slate, gneiss and dolomite (Fig. 5). The number of landslides in the quartzite area is small, however, landslide's number per one square kilometer is the highest. This simply depends on that area dimension of quartzite is quite narrow (Table 1). The phyllite area shows relatively lower occurrence number of earthquakeinduced landslides except along the gorge of the Sun Kosi and the Bhote Kosi Rivers. It is presumably attributed to that most of phyllitic rock is underlain in the Midland side where relief is relatively low.
